Performance Report – Magnetic Mount Antenna Test

Tested Equipment

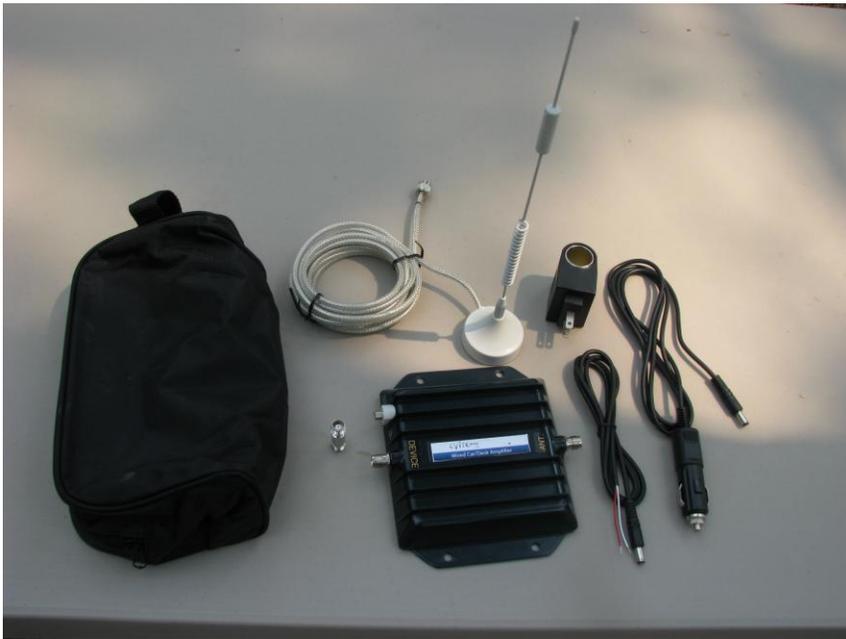
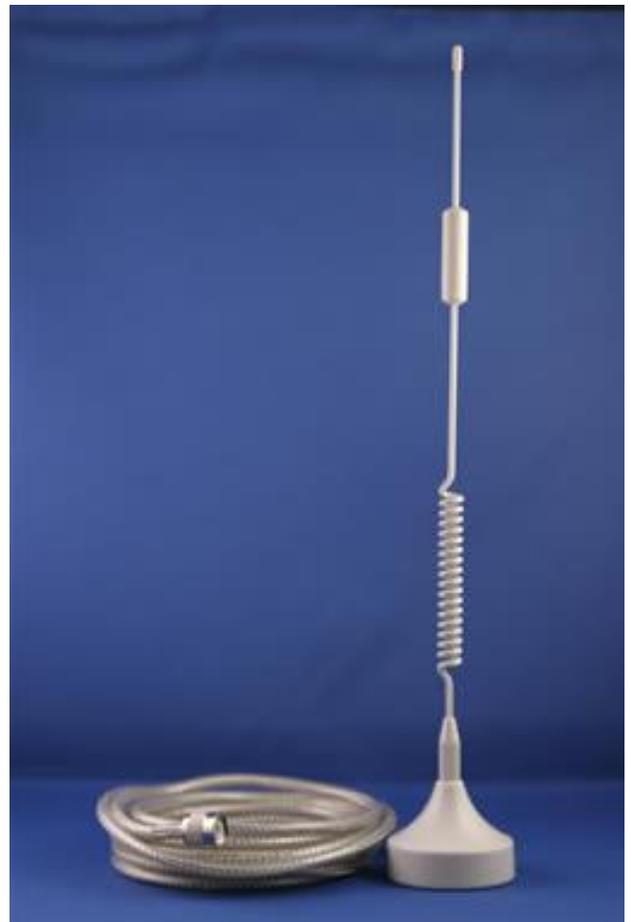
The first two pictures below show the 5dBi antenna. On the left, with the Cyfre amplifier kit.

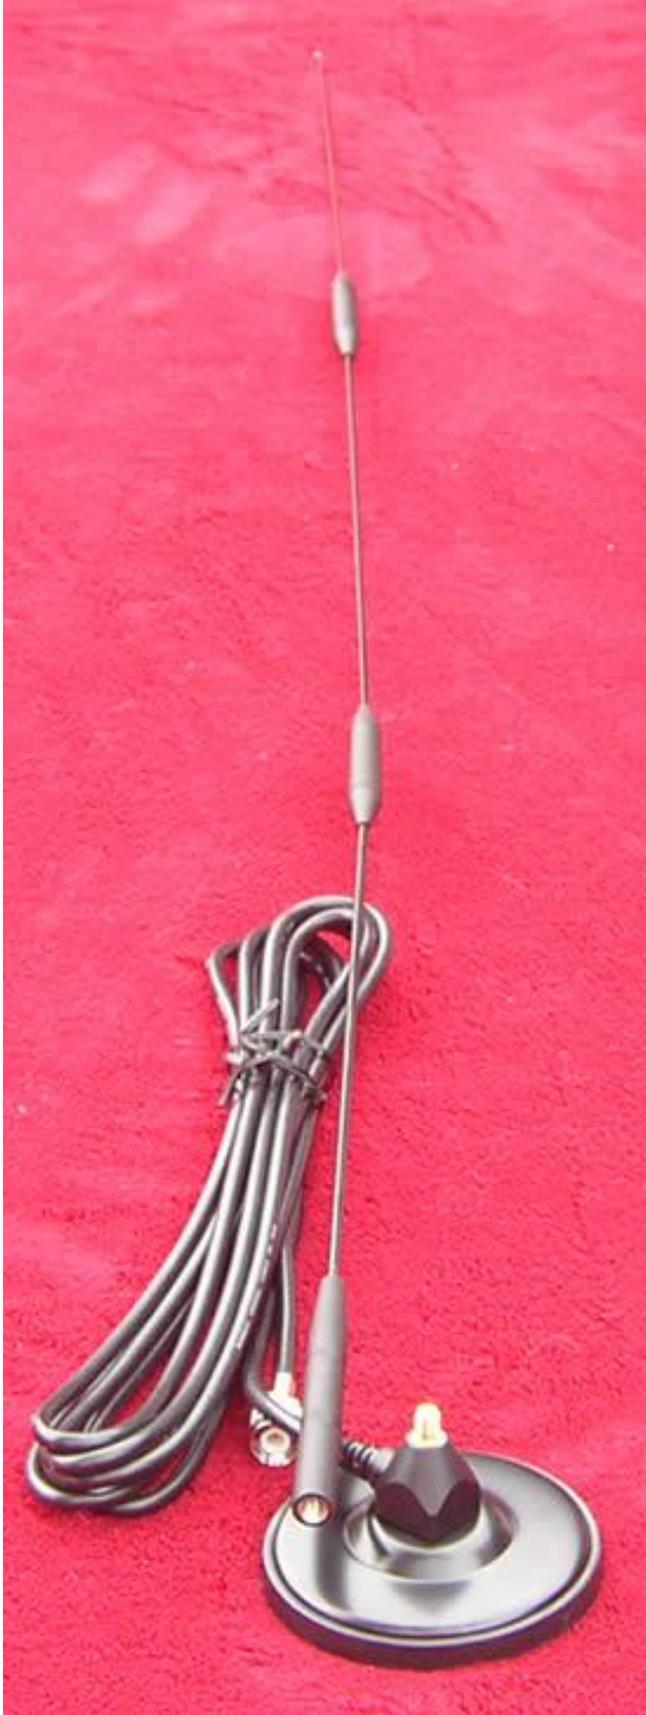
This is the 39" antenna.

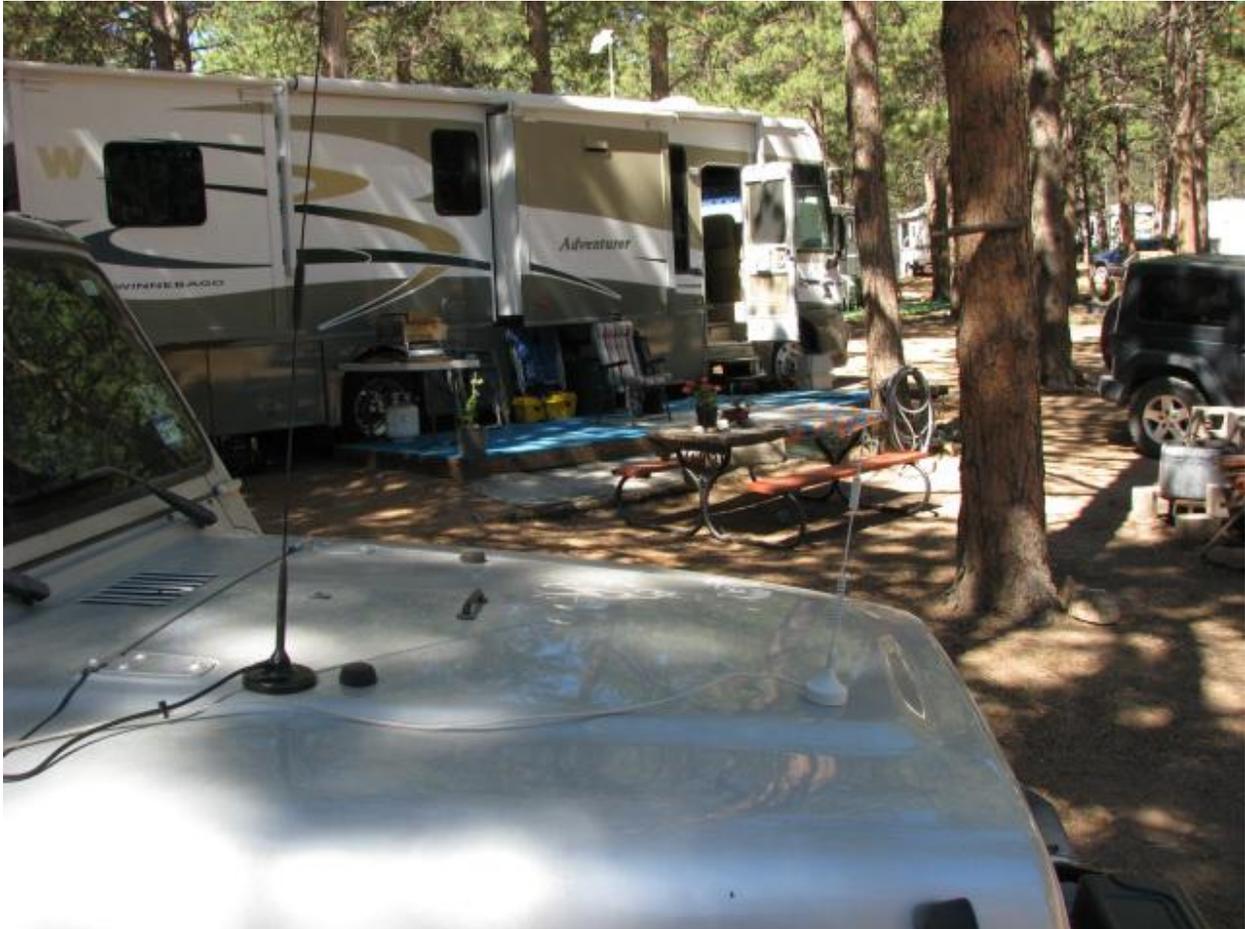
I tested this in a vehicle, and moved to various locations that I know have poor reception. The test vehicle was a Jeep Wrangler with a hardtop. Both magnetic mount external antennas were mounted on the hood. This is about 4' off the ground. While mounting in the center of the roof of the vehicle is technically a better location it is not possible with a mag mount antenna, since the Jeep roof is fiberglass. The location on the hood gave unobstructed 360 degree access to the cellular towers – but a higher location on the roof might have been better. The larger 39" antenna is the black one closest to the windshield, the smaller 13" one is to the right.

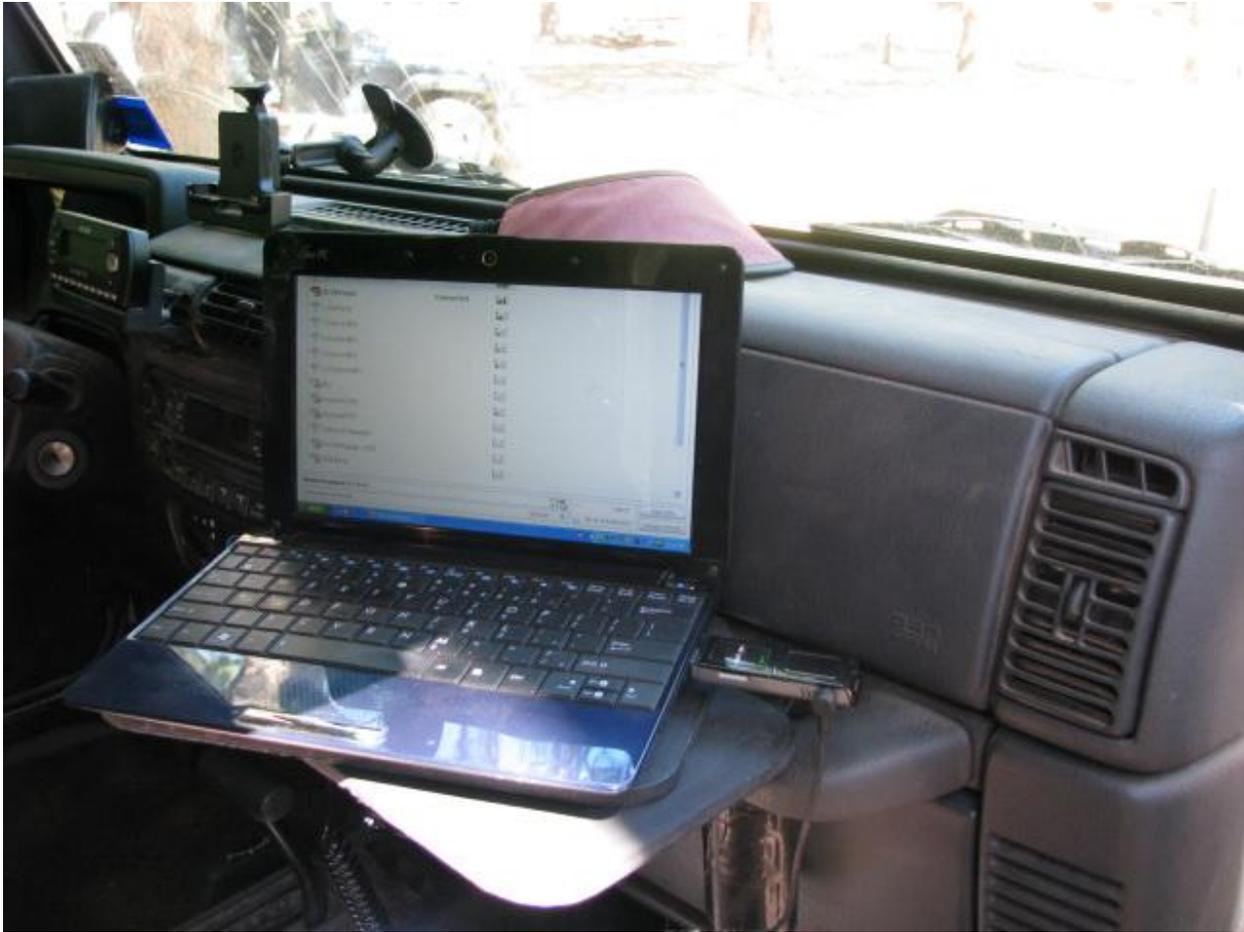
An Asus Eee Netbook, the latest version of Verizon VZ Access Manager and a Verizon 727 cellular modem (aircard) was used to test signal at each of three locations. Only 3G testing was done since the aircard is a 3G-only card.
